# Commercialization of Military & Space Electronics - Conference

**Commercial Off-The-Shelf (COTS) Program**  
Using Nondestructive Methods (C-SAM) for COTS  
PEMs Screening and Qualification

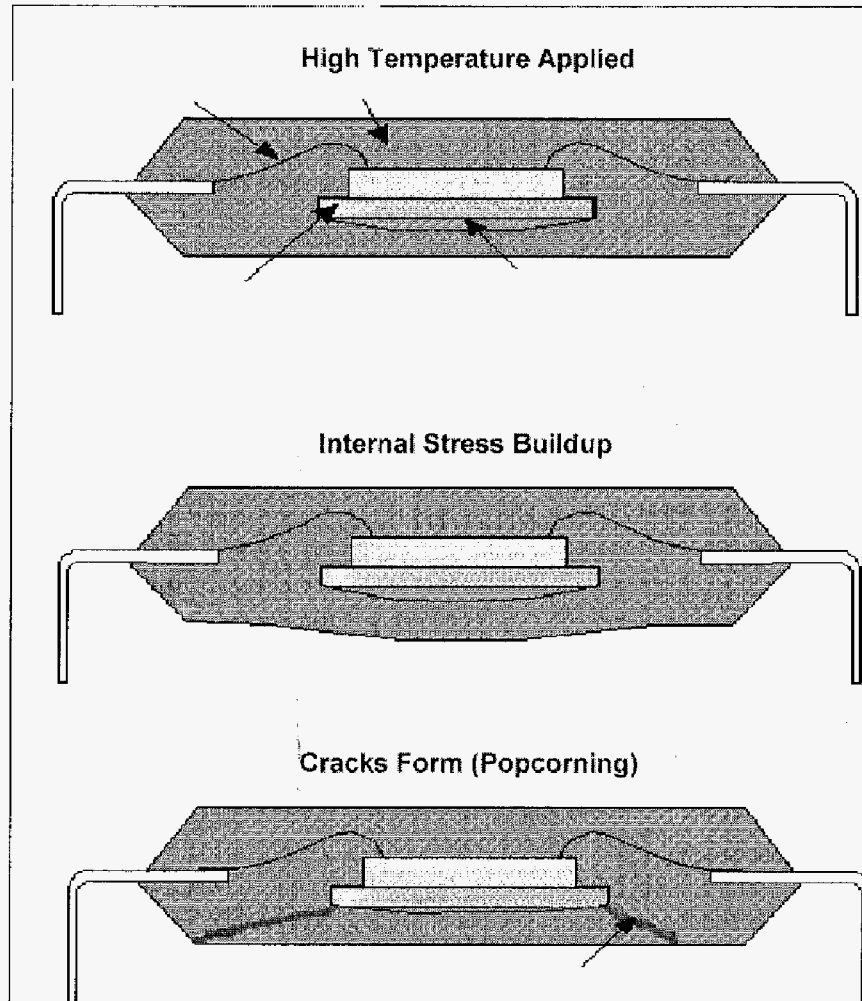
# Popcorning Failure Mechanism from Internal Moisture

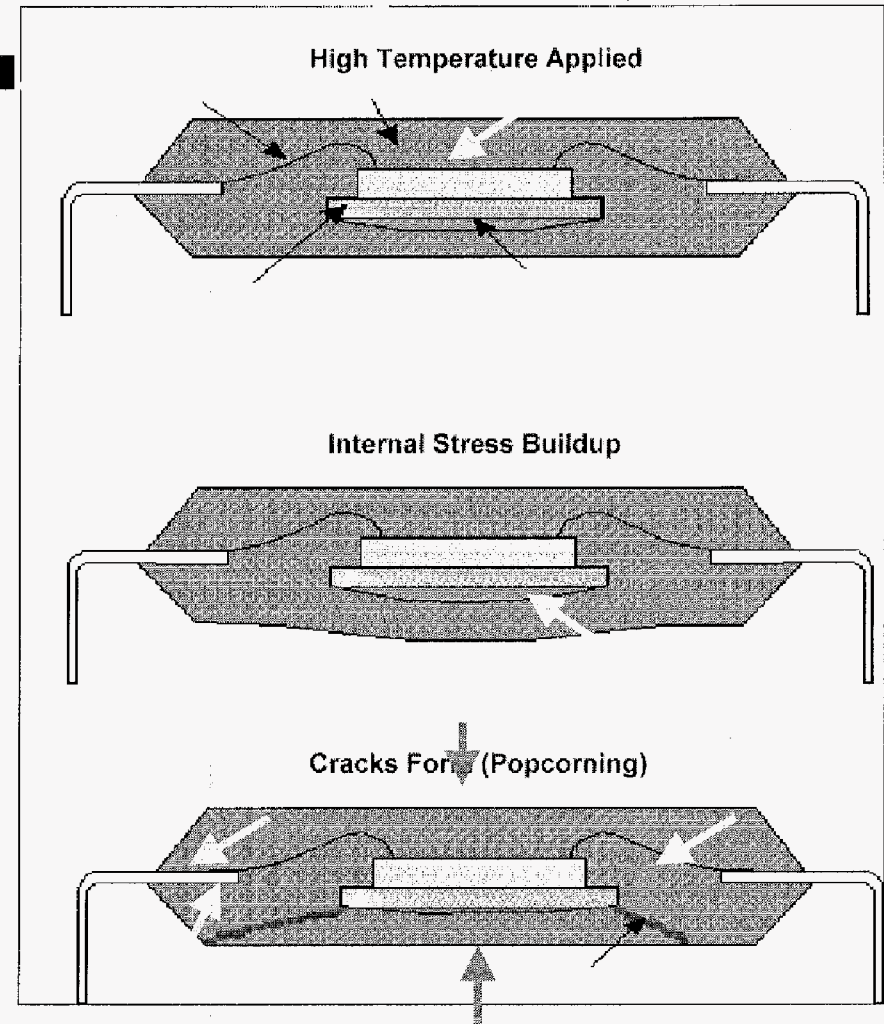
# C-SAM Inspection Points for delamination

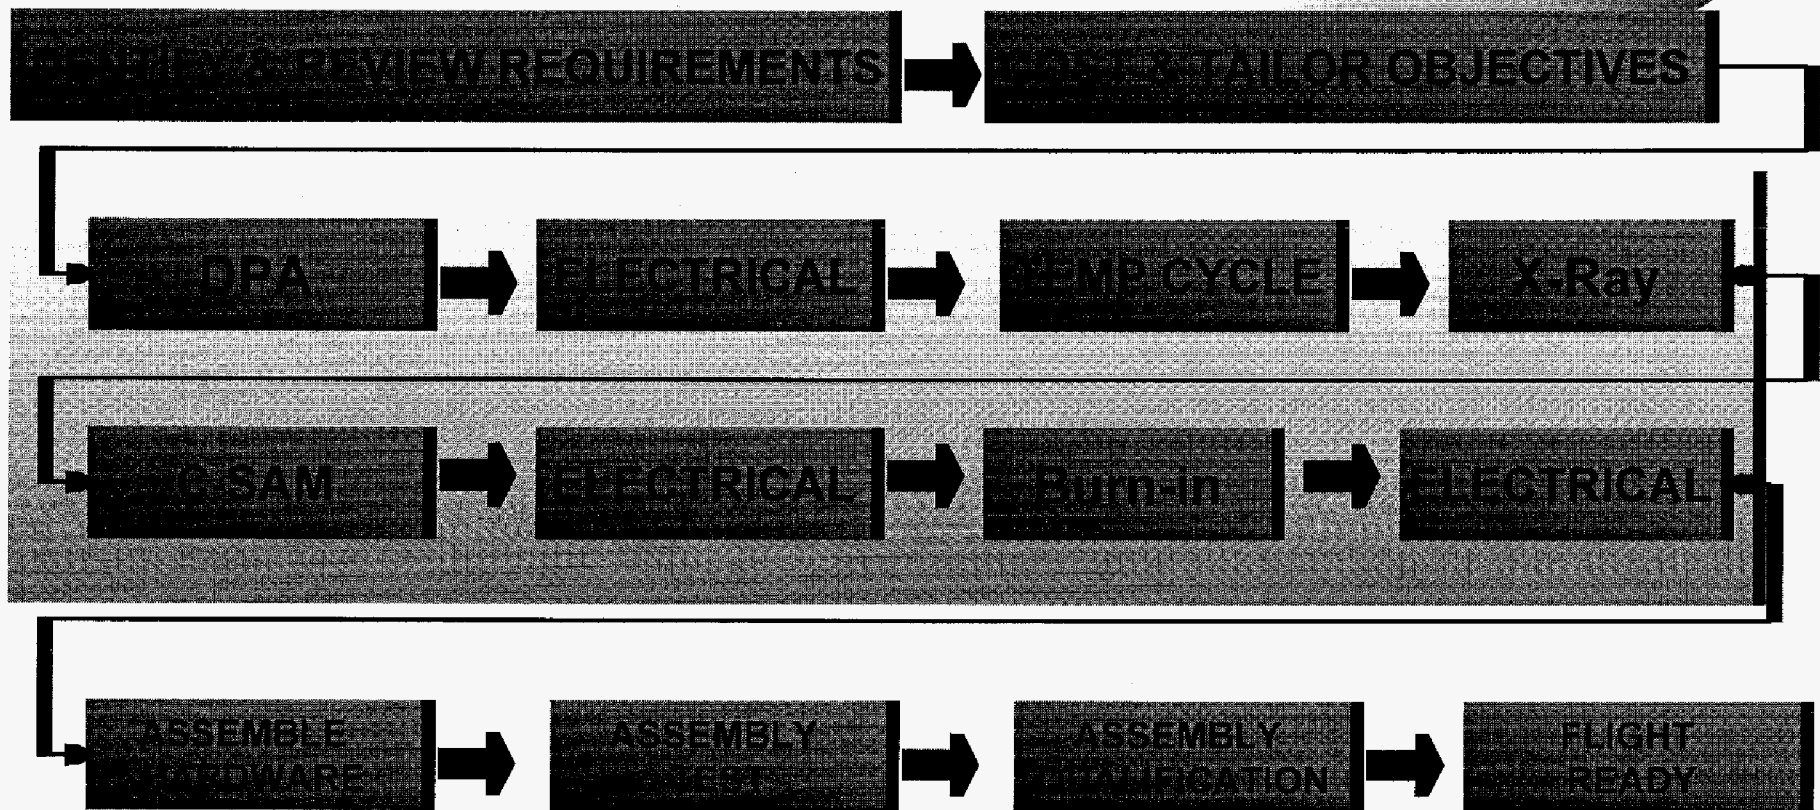
**COTS<sup>++</sup> Plastic Infusion Critical Screening Flow**  
**(Tailored for Project application/mission requirements)**

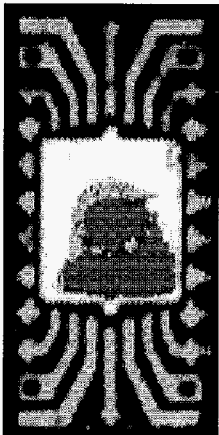
**C-SAM Rejects (JPL examples):** (Devices with  $>> 10\%$  delamination in critical areas are suspect and are rejected)

Reject

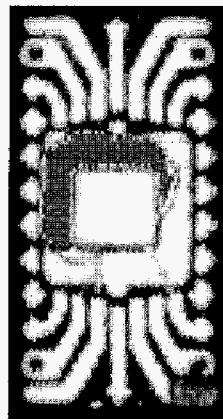
Reject

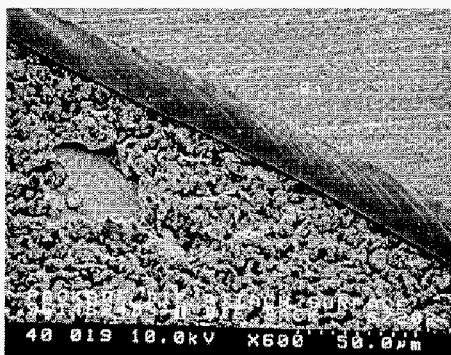
A. Die attach void at  
the heat sink surface

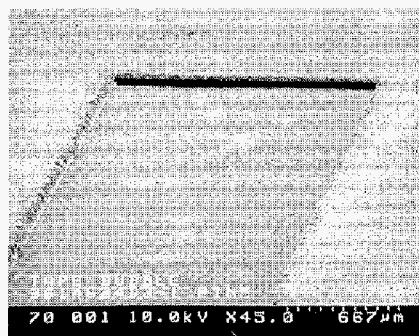
B. Bubble exists from  
Mylar tape near pin 5

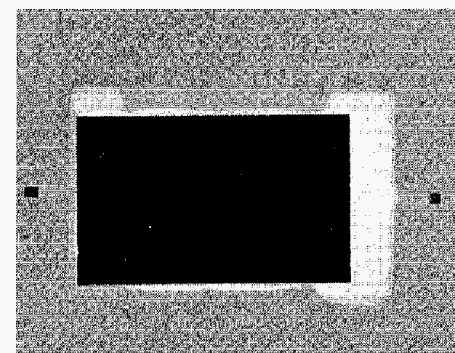
C. Delamination and lack  
of adhesion between  
die and heat sink
